Residential Tornado Safe Rooms from Commodity Wood Products Wall Development and Impact Testing

Research Paper
FPL-RP-681

October
2015

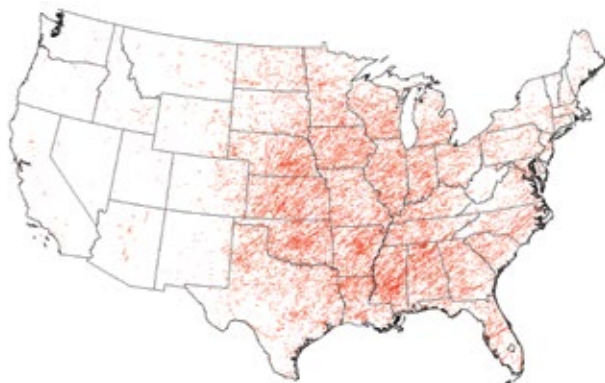
Figure 1—Tornado activity in the United States from 1950–2013 (Source: Storm Prediction Center 2014).

A significant portion of the United States is susceptible to the dangerous winds of tornadoes (Fig. 1). Every year, these events cause injury, death, and billions of dollars of property damage (FEMA 2014). Improved weather forecasting, increased lead-in times for tornado warning, and the development of reinforced safe rooms has helped reduce the human toll from these events.

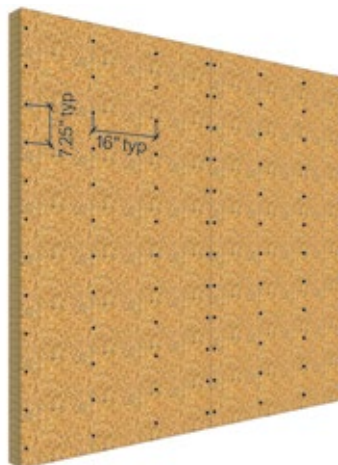
Figure 4—Sheathing nailing pattern for stacked 2 × 4 walls.

The first wall type investigated was constructed by stacking and nailing 2 × 4s (stud grade, SPF species) into a solid slab of wood. This slab was then covered with oriented strand-board (OSB) sheathing on the exterior faces (Fig. 2). To fasten each 2 × 4 layer, 16d smooth shank round head nails, 3 in. long, were nailed vertically using a pneumatic framing nailer in the nailing pattern shown in Figure 3. The sheathing was nailed to the stacked 2 × 4s as shown in Figure 4 using 16d, 2-3/8-in.-long nails. These were also driven with a framing nailer.

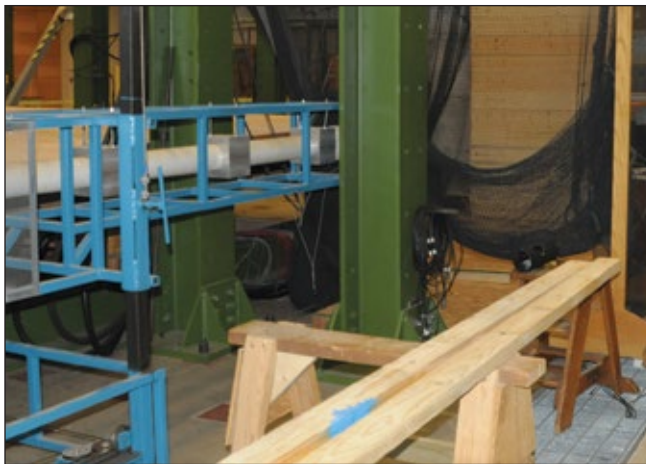
Figure 11—Test cannon and 2 × 4 missiles.

The impact tests were performed at the Forest Products Laboratory using a missile cannon (Fig. 11) built by Spudtech, LLC (New London, Minnesota). The cannon used compressed air to propel the missile, and the pressure of the compressed air could be adjusted to control the speed of the missile. Missile speed was measured using a photoelectric timing device.

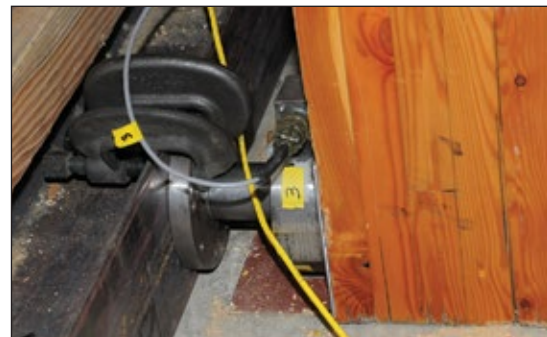
Figure 12—One of four load cells used to monitor force of impact.

the impact force transmitted to each corner of the impacted wall (Fig. 12). Four TRANS-TEK Model 0244, ± 1.00 in. displacement transducers (TRANS-TEK, Inc., Ellington, Connecticut) were also connected to the back side of each wall to record the deflection of the wall during impact (Fig. 13). Location of these devices is shown in Figure 14.

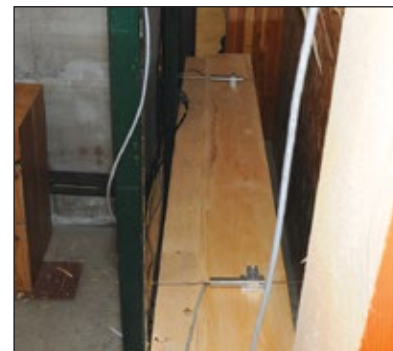
Figure 13—Two of four displacement transducers used to monitor wall displacement.

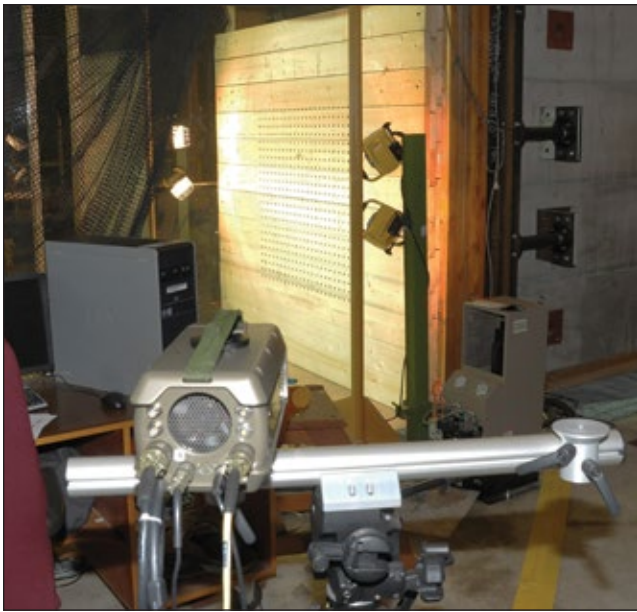
Figure 16—High-speed camera setup.

Two high-speed Vision Research V710 cameras (Vision Research, Wayne, New Jersey) were used to capture the dynamic out-of-plane displacement response of the wall for each test. Using Phantom Camera Control software (Vision Research), the cameras were triggered to start coincidentally with the LabVIEW data collection and recorded the movement of a 23×23 array of 0.5-in.-diameter black dots painted 2 in. on center (Figs. 6a and 16). These high-speed videos were recorded at a resolution of 800×800 and speed of 7,000 frames per second. The out-of-plane displacement of the walls was determined using the mesh-free random grid method (Iliopoulos et al. 2012).

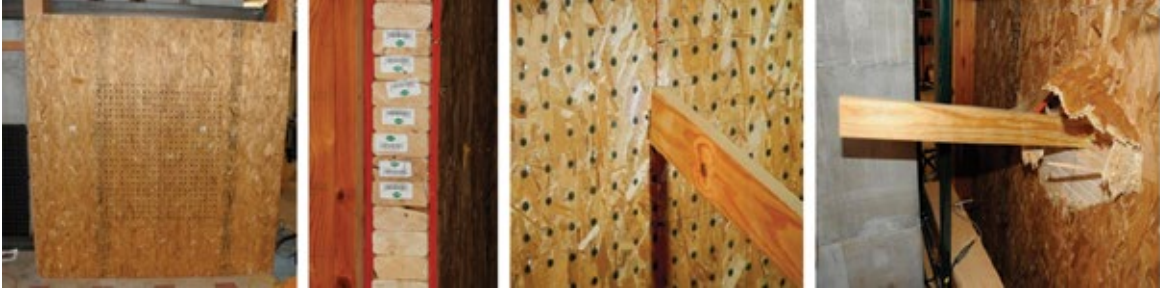
Wall ID	Wall construction	Missile speed (mph)	Front penetration (in.)	Permanent wall deflection (in.)	Wall perforated (Y/N)	Observed damage	Passed test? (Y/N)	Additional notes
1a	Stacked 2 × 4s. Nailed 16 in. on center (oc). Sheathing both sides with 1/2-in. OSB.	97.8	—	—	Y	Missile completely pierced wall. Significant debris.	N	First shot on Wall 1. Impact 0 in. right, 3 in. below center.

<p>Left to right: Wall before test, wall construction, impact damage to front of wall, impact damage to back of wall.</p>								
1b	Stacked 2 × 4s. Nailed 16 in. oc. Sheathed both sides with 1/2 in. OSB.	102.2	—	—	Y	Missile completely pierced wall. Significant debris.	N	Second shot on Wall 1. Impact 18 in. left, 10 in. above center.

As indicated in the photographs of the Appendix, Wall 1 showed little resistance to the impact and the 2×4 easily pierced the wall in all three tests. Wall 2 failed the test because the permanent wall deformation was 3 in., the maximum allowed by the test standard. No significant debris was generated.

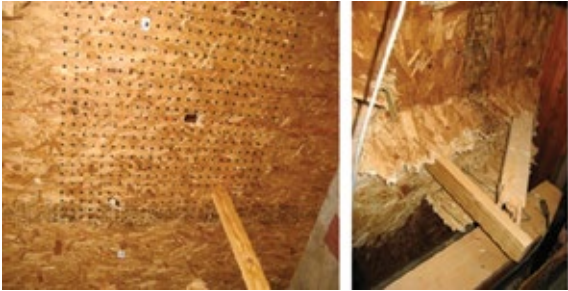
<p>Left to right: Impact damage to front of wall, impact damage to back of wall.</p>								
1c	Stacked 2 × 4s. Nailed 16-in. oc. Sheathed both sides with 1/2-in. OSB.	103.0	—	—	Y	Missile completely pierced wall. Significant debris.	N	Third shot on Wall 1. Impact 16 in. left, 13 in. below center.

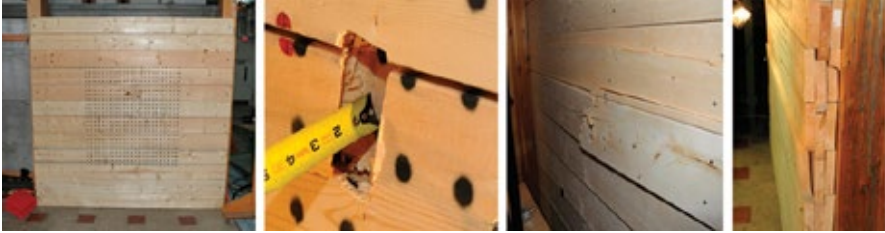
Wall ID	Wall construction	Missile speed (mph)	Front penetration (in.)	Permanent wall deflection (in.)	Wall perforated (Y/N)	Observed damage	Passed test? (Y/N)	Additional notes
2	Interlocking 3-ply sections of 2 × 8. No sheathing.	99.4	1.6	3.0	N	Wall displacement maximum allowable. No significant debris.	N	Impact at seam between 2 × 8 layers.

<p>Left to right: Wall before test, impact damage to front of wall, impact damage to back of wall, side view of wall damage.</p>								
3a	Interlocking 3-ply sections of 2 × 8. 1/2-in. OSB sheathing nailed to back side.	97.0	1.5	0.5	N	Cracking of OSB on back side. No significant debris.	Y	Similar to Wall 2 with added 1/2-in. OSB. Impact 3 in. right, 0 in. below center.

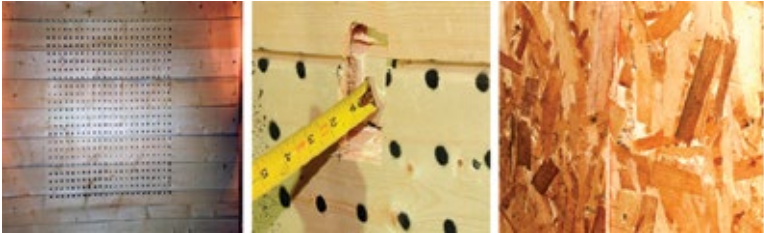
<p>Left to right: Wall before test, impact damage to front of wall, impact damage to back of wall.</p>								
3b	Interlocking 3-ply sections of 2 × 8. 1/2-in. OSB sheathing nailed to back side.	100.5	2.8	4.1	Y	Missile pierced wall. Significant debris. Severe cracking of OSB.	N	Second shot on Wall 3. Impact 1 in. left, 0 in. below center.

The first impact test of Wall 3 (Wall Test 3a) resulted in a permanent deflection of 0.5 in. and no significant debris; however, a second shot on the same wall (Wall Test 3b) resulted in the 2×4 piercing the wall and a large permanent deflection. Unlike Wall 3, Wall 4 failed on the first shot (8.9 in. of deflection) because of a failure of the sheathing.

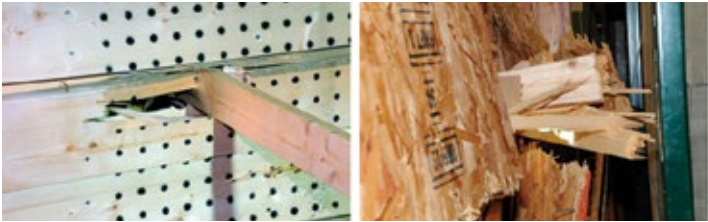
<p>Left to right: Impact damage to front of wall, impact damage to back of wall.</p>								
4	Interlocking 3-ply sections of 2 × 8. 1/2-in. OSB sheathing nailed to back side.	97.0	1.8	8.9	N	8.9-in. defect is from a section of delaminated OSB. Lumber deflection is closer to 1.5 in.	N	Same as Wall 3.

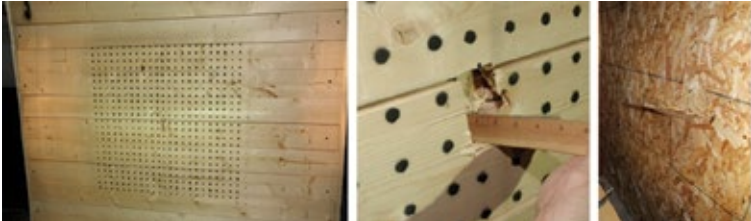
<p>Left to right: Wall before test, impact damage to front of wall, impact damage to back of wall.</p>

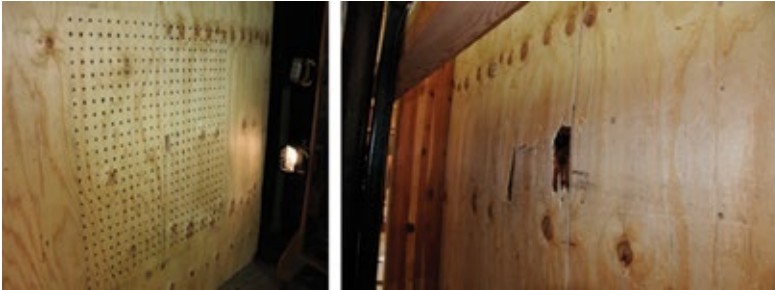
Impact damage to front of wall.						
5b	Interlocking 3-ply sections of 2 × 8. 23/32-in. plywood sheathing both sides. No adhesive.	102.6	2.5	1.5	N	Two pieces of plywood veneer, about 4 in. in length, dislodged from rear of panel.	N	Second shot on Wall 5. Impact 0.5 in. right, 12 in. above center.

Left to right: Wall before test, impact damage to back of wall.						
6a	Interlocking 3-ply sections of 2 × 8. 23/32-in. plywood sheathing both sides. Adhesive applied to plywood only.	104.5	2.0	0.5	N	Some permanent deformation and light cracking of plywood on back side of wall. No debris.	Y	First shot on Wall 6. Impact 2 in. left, 1 in. above center.

The first shot on Wall 5 (Wall Test 5a) resulted in 1.5 in. of permanent deflection and no debris was generated. A second shot (Wall Test 5b) also resulted in 1.5 in. of deflection; however, two small pieces of plywood veneer were dislodged and the test deemed a failure.

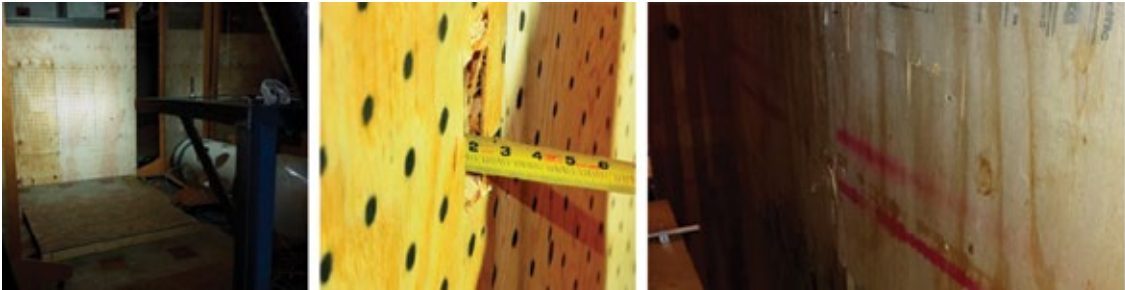
Left to right: Wall before test, impact damage to front of wall, impact damage to back of wall.

As indicated in the Appendix, Wall 6 was impacted four times and the first three impacts resulted in permanent wall deformation less than 2 in. and only slight cracking of the plywood. The fourth shot resulted in failure because the permanent deflection was 3.1 in., slightly greater than allowed. No debris was generated in this series of tests.

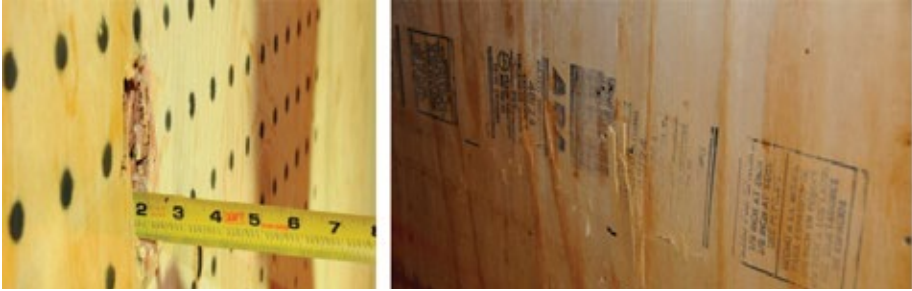
Wall ID	Wall construction	Missile speed (mph)	Front penetration (in.)	Permanent wall deflection (in.)	Wall perforated (Y/N)	Observed damage	Passed test? (Y/N)	Additional notes
6b	Interlocking 3-ply sections of 2 × 8. 23/32-in. plywood sheathing both sides. Adhesive applied to plywood only.	103.5	2.1	1.8	N	Some permanent deformation and cracking of plywood on back side of wall. No debris.	Y	Second shot on Wall 6. Impact 0 in. right, 12 in. above center.

Left to right: Impact damage to front of wall, impact damage to back of wall.						
6c	Interlocking 3-ply sections of 2 × 8. 23/32-in. plywood sheathing both sides. Adhesive applied to plywood only.	104.2	2.0	1.9	N	Some permanent deformation and more severe cracking of plywood on back side of wall. No debris.	Y	Third shot on Wall 6. Impact 1 in. right, 12 in. below center.

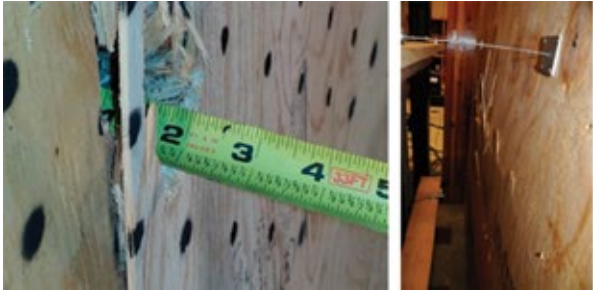
Left to right: Impact damage to front of wall, impact damage to back of wall.

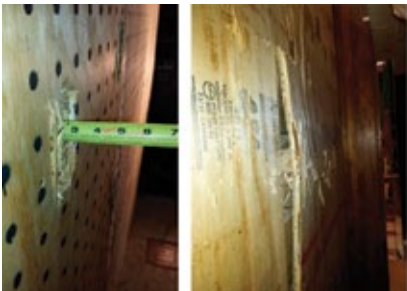
6d	Interlocking 3-ply sections of 2 × 8. 23/32-in. plywood sheathing both sides. Adhesive applied to plywood only.	103.9	3.0	3.1	N	Excessive permanent deformation and splitting of plywood on back side of wall. No debris.	N	Fourth shot on Wall 6. Impact 13 in. left, 1 in. below center.

Left to right: Impact damage to front of wall, impact damage to back of wall.

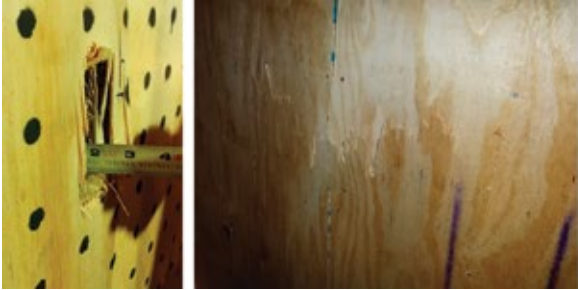
Wall ID	Wall construction	Missile speed (mph)	Front penetration (in.)	Permanent wall deflection (in.)	Wall perforated (Y/N)	Observed damage	Passed test? (Y/N)	Additional notes
7a	Interlocking 3-ply sections of 2 × 8. 23/32-in. plywood sheathing both sides. Adhesive applied between 2 × 8 plies and on the plywood.	102.0	2.4	1.4	N	Minor cracking of plywood.	Y	First shot on Wall 7. Impact 1 in. left, 0.5 in. below center.

Left to right: Impact damage to front of wall, impact damage to back of wall.						
7b	Interlocking 3-ply sections of 2 × 8. 23/32-in. plywood sheathing both sides. Adhesive applied between 2 × 8 plies and on the plywood.	102.3	1.9	1.5	N	Minor cracking of plywood.	Y	Second shot on Wall 7. Impact 2 in. left, 12 in. above center.

Wall 7 was constructed the same as Wall 5; however, construction adhesive was added between the 2×8 s making up the wall beams as well as between the plywood sheathing and the 2×8 beams (see Figs. 10, 11). This wall was shot four times, and the first three impacts resulted in permanent wall deformation less than 1.5 in. and only slight cracking of the plywood. The fourth shot resulted in failure with a permanent deflection of 3.9 in. No debris was generated in this series of tests.

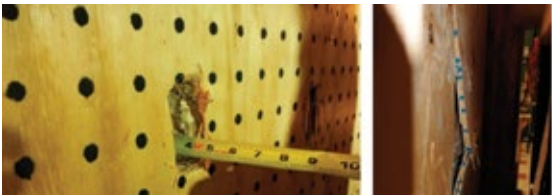
Impact damage to back of wall.						
7d	Interlocking 3-ply sections of 2 × 8. 23/32-in. plywood sheathing both sides. Adhesive applied between 2 × 8 plies and on the plywood.	101.1	4.3	3.9	N	Excessive permanent deformation and splitting of plywood on back side of wall. No debris.	N	Fourth shot on Wall 7. Impact 13 in. left, 0 in. below center.

Left to right: Impact damage to front of wall, impact damage to back of wall.

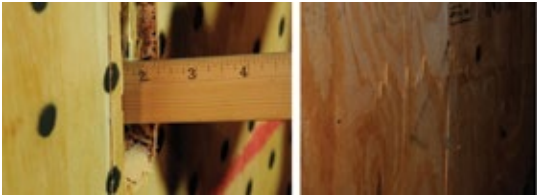
Wall ID	Wall construction	Missile speed (mph)	Front penetration (in.)	Permanent wall deflection (in.)	Wall perforated (Y/N)	Observed damage	Passed test? (Y/N)	Additional notes
8a	Interlocking 3-ply sections of 2 × 8. 23/32-in. plywood sheathing both sides. Adhesive applied between 2 × 8 plies, 2 × 8 sections, and between plywood and 2 × 8 sections.	101.0	2.1	0.6	N	Minor cracking of plywood.	Y	First shot on Wall 8. Impact 1 in. right, 2 in. below center.

Left to right: Impact damage to front of wall, impact damage to back of wall.						
8b	Interlocking 3-ply sections of 2 × 8. 23/32-in. plywood sheathing both sides. Adhesive applied between 2 × 8 plies, 2 × 8 sections, and between plywood and 2 × 8 sections.	104.6	3.0	1.6	N	Minor cracking of plywood.	Y	Second shot on Wall 8. Impact 0 in. right, 11 in. above center.

The final series of impact tests were performed on Wall 8. Also constructed the same as Wall 5, this wall included construction adhesive between the 2×8 s making up the wall beams, between the 2×8 wall beams, and between the plywood sheathing and the 2×8 beams (see Figs. 9–11). This wall was shot six times. The first four impacts resulted in permanent wall deformation less than 2 in. and only slight cracking of the back side plywood face. The fifth shot resulted in a permanent deflection of 2.6 in. and the sixth shot resulted in failure with a permanent deflection of 5.9 in. No debris was generated in this series of tests, although the last test resulted in the separation of the plywood from the 2×8 s in the area of impact.

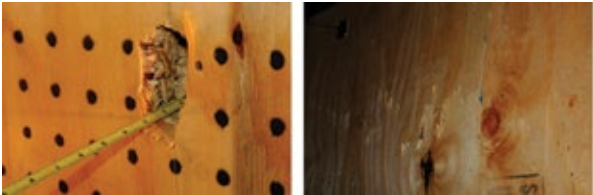
Left to right: Impact damage to front of wall, impact damage to back of wall.

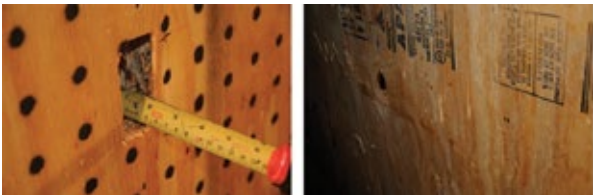
8c	Interlocking 3-ply sections of 2 × 8. 23/32-in. plywood sheathing both sides. Adhesive applied between 2 × 8 plies, 2 × 8 sections, and between plywood and 2 × 8 sections.	103.1	2.0	1.8	N	Minor cracking of plywood.	Y	Third shot on Wall 8. Impact 1.5 in. left, 14 in. below center.

Left to right: Impact damage to front of wall, impact damage to back of wall.						
8d	Interlocking 3-ply sections of 2 × 8. 23/32-in. plywood sheathing both sides. Adhesive applied between 2 × 8 plies, between 2 × 8 sections, and on plywood.	103.1	2.5	1.9	N	Minor cracking of plywood.	Y	Fourth shot on Wall 8. Impact 13 in. left, 0 in. above center.

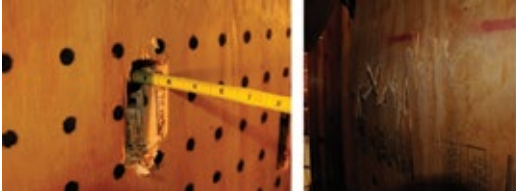
Wall ID	Wall construction	Missile speed (mph)	Front penetration (in.)	Permanent wall deflection (in.)	Wall perforated (Y/N)	Observed damage	Passed test? (Y/N)	Additional notes
8e	Interlocking 3-ply sections of 2 × 8. 23/32-in. plywood sheathing both sides. Adhesive applied between 2 × 8 plies, between 2 × 8 sections, and on plywood.	104.5	3.5	2.6	N	Minor cracking of plywood.	Y	Fifth shot on Wall 8. Impact 13 in. left, 10 in. below center.

<p>Left to right: Impact damage to front of wall, impact damage to back of wall.</p>								
8f	Interlocking 3-ply sections of 2 × 8. 23/32-in. plywood sheathing both sides. Adhesive applied between 2 × 8 plies, between 2 × 8 sections, and on plywood.	104.3	5.3	5.9	N	Missile perforated the 2 × 8 plies, though not the plywood. Back side plywood was separated from the 2 × 8s in area of impact.	N	Sixth shot on Wall 8. Impact 12 in. left, 11 in. above center.
